Trialling amphibian ladders within roadside gullypots in Angus, Scotland: 2014 impact study

ABSTRACT - Gullypots (roadside drains) have long been a problem for amphibians and other animals as a source of entrapment and certain death. Where the problem prevails close to migration routes for amphibians, the threat to local populations is significant and can devastate numbers each breeding season. Combined with existing known threats such as road death, road salting, agrichemicals, pollution and habitat damage, the dangers of gullypot entrapment can further imperil local populations to an unsustainable level. In the first UK trial of its kind, this study aimed to mitigate the gullypot problem with the installation of a simple ladder device which can be tailored and retrofitted in all circumstances. The authors adapted a design, trialled it in a known problem location and recorded findings. This study aimed to determine if the ladders can be ascended by UK widespread species, demonstrate the effectiveness of the amphibian ladders and quantify the extent of the problem using a robust dataset.

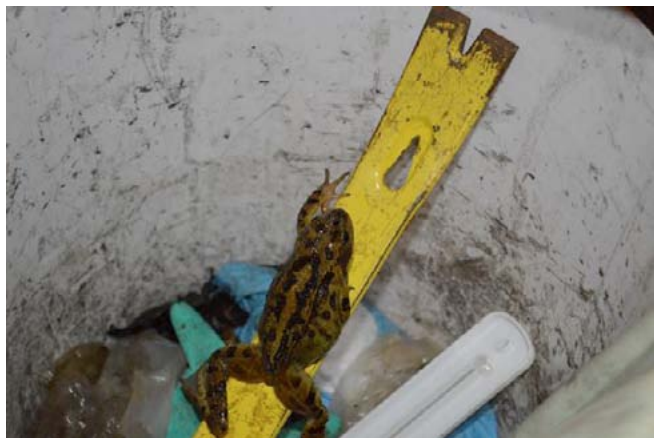
of laboratory trials beginning. Fig. 6 shows a *R. temporaria* using a pry bar as a ladder that was being carried within the collection bucket. For this reason, we consider the overall results of this study and the data collected to be conservative, as it was not practical to attend the site around

Figure 6. Frog using pry bar to escape from the collection bucket. Photo credit: McInroy, C

We did not see any toads in amplexus using the ladders, nor did we observe any frogs performing an escape. However, on several occasions frogs were witnessed sitting on the tops of ladders but when illuminated by torch they would jump off back into the gullypot. It is possible that as the frogs are more agile and flighty, they are more likely to find the escape route immediately and escape before they can be recorded. RAVON reported that some common frogs and edible frogs (*Pelophylax esculenta*) escaped using ladders with ten minutes
